Thursday, September 19, 2019

Level 2, Premium Reserve Analysis

Terraces at Meadow Run

101-1402 Meadow Run

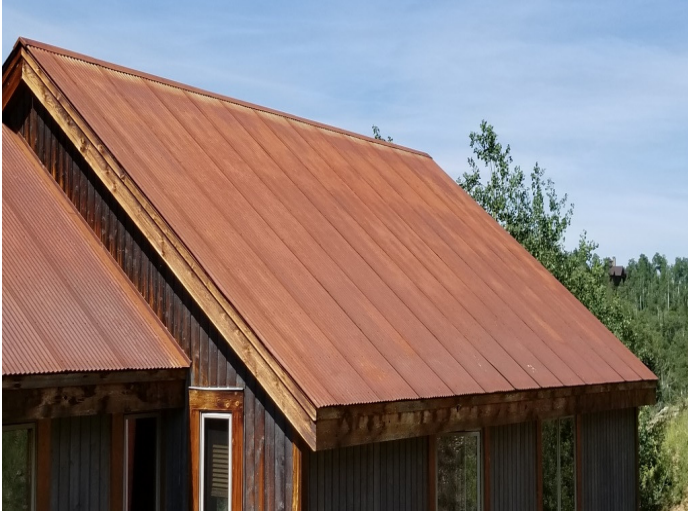
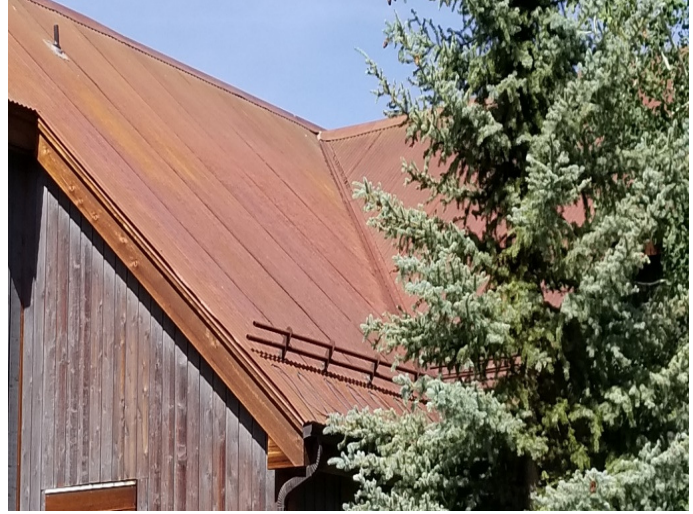
Comp #: 109 Steel Roof - Inspect/Major Repairs

- Establish funding for periodic inspections and minor repairs.
- At this time, there is no expectancy to completely replace the roof as long as proper maintenance and minor repairs occurs every 4 - 5 years.

Best Cost: **\$10,000**
\$1250/building; Estimate to inspect and repair

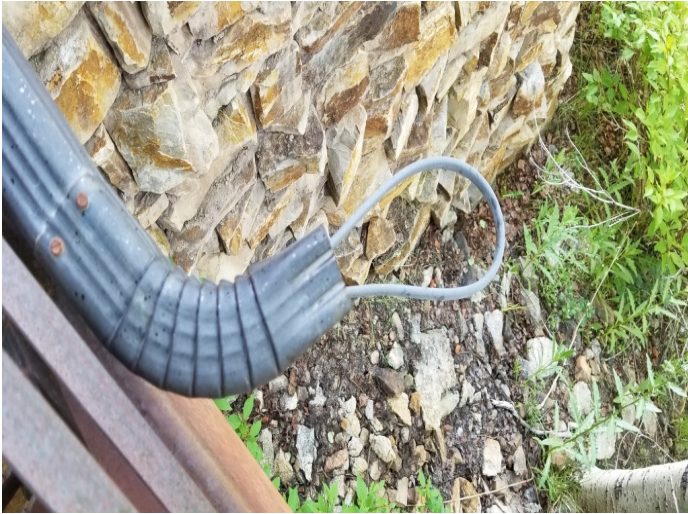
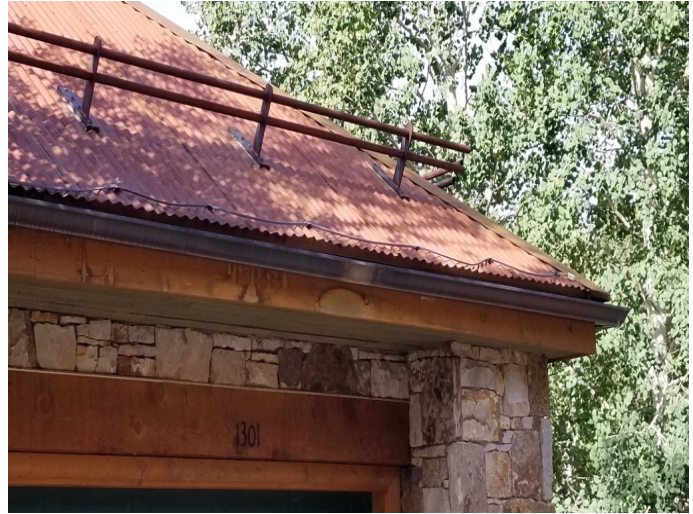
Comp #: 120 Rain gutters/Downspouts - Replace

- Copper lines will have an extended life expectancy in excess of 50 years under normal conditions.
- In most situations, galvanized or aluminum gutters have a life expectancy of 20 - 30 years.
- The estimated cost for this component only includes the aluminum lines, not the copper lines.
- Remaining life based on age and observed condition.

NOTE - During replacement, if materials are upgraded to copper, then remove Reserve funding for future replacement at that time.

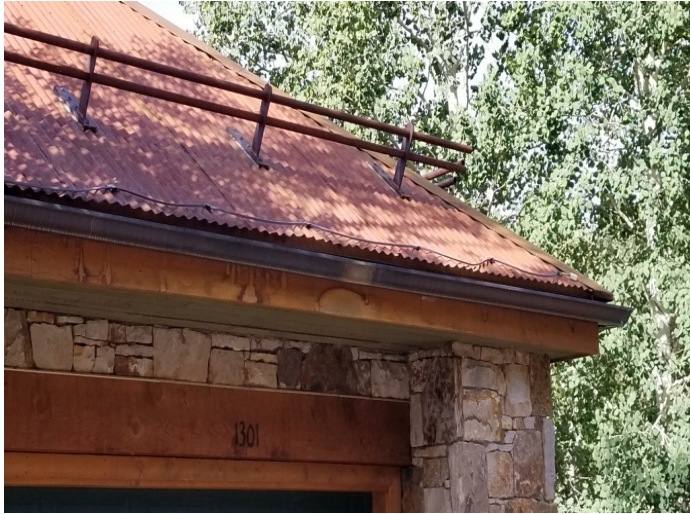
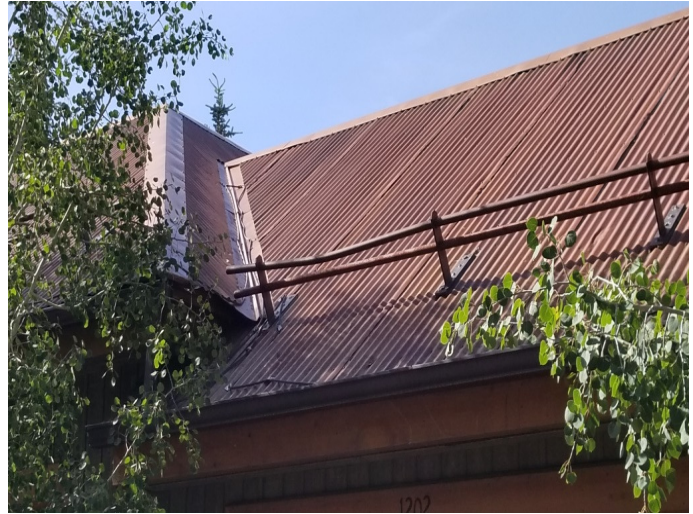
Comp #: 121 Heat Elements - Replace

- In 2019, some heat tape was repaired on building #1101/1202
- We suggest including Reserve funding along with the building roof inspection and repair line item (see component #109)
- Separate Reserve funding is not required for this component at this time.

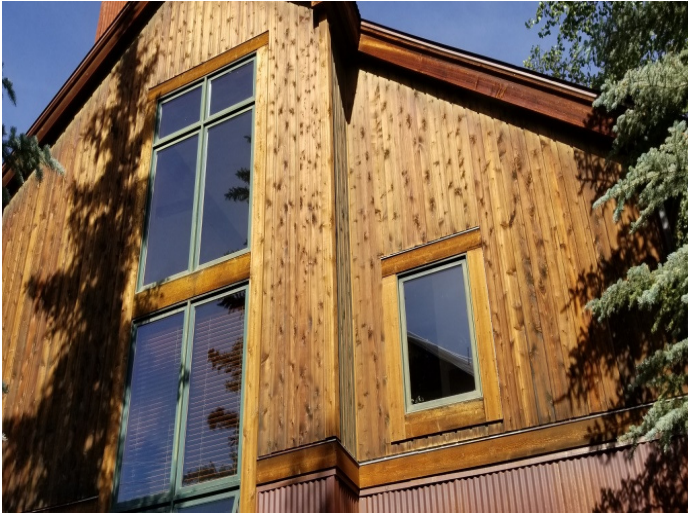
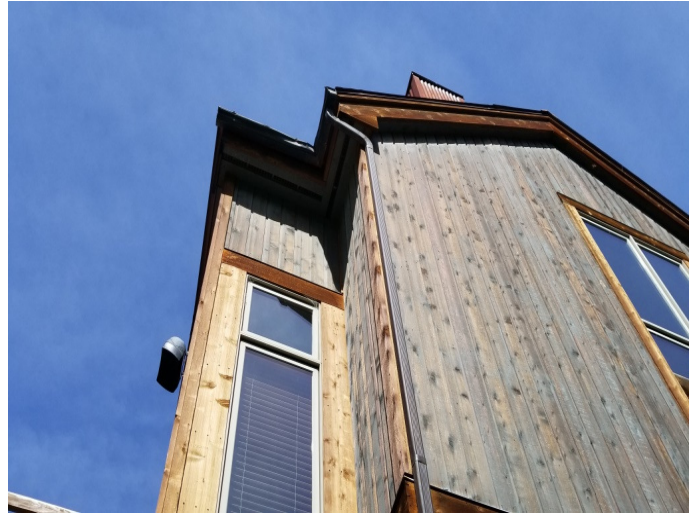
Comp #: 204 Building Ext Surfaces - Restain

- All buildings were in process of being stained in the summer of 2019.
- In this climate, it is recommended that exterior surfaces are restained every 4 - 5 years.
- The exact timeframe depends on the color chosen and the level of exposure to elements, as well as the quality of past paint jobs.
- The remaining life is based on the observed conditions.

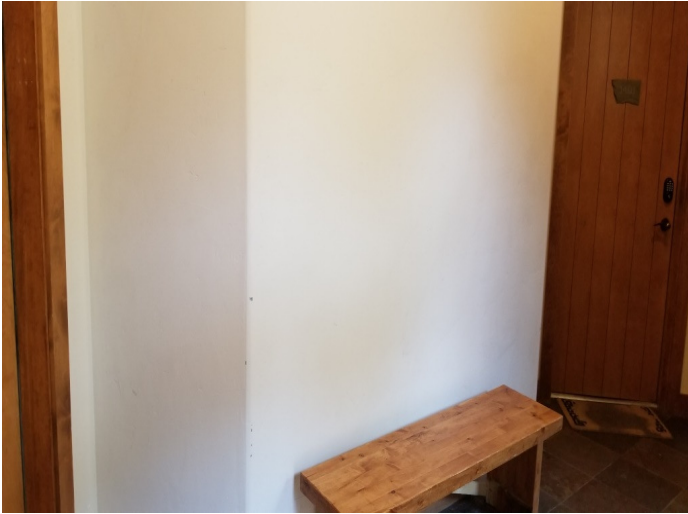
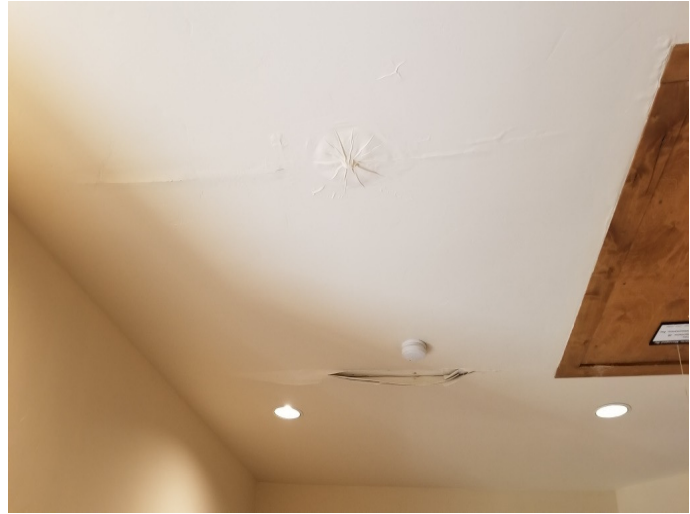
Comp #: 216 Interior Surfaces - Repaint

- Peeling paint in ceiling of building # 1301/1402 from what appears to have been a water leak from the boiler equipment room above this area. It was reported at the time of reviewing the draft report that this area has been repaired and repainted. Some other general nicks and marks were observed as well throughout all of the buildings. Conditions of garages vary.
- We recommend reserving to repaint the interior spaces every 6 - 8 years to maintain appearance.
- Outside of this painting cycle, damage to the surfaces and touch-up work should be performed annually with operating funds.

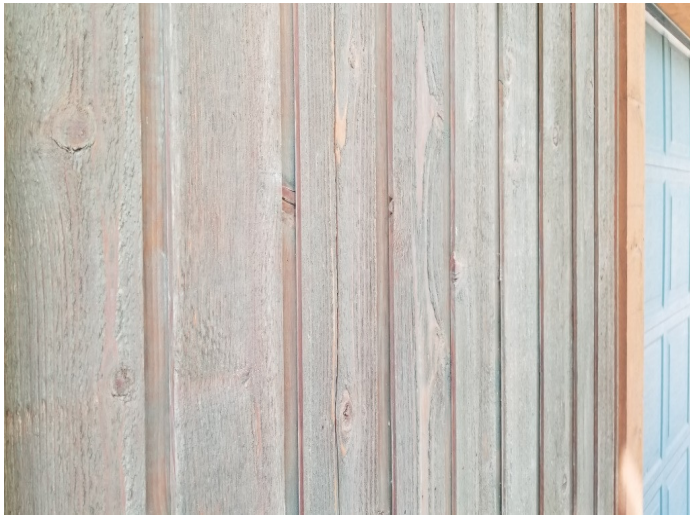
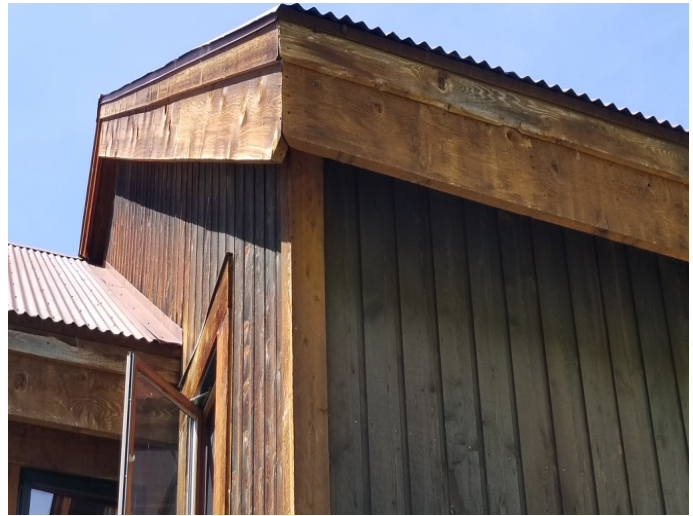
Comp #: 303 Wood Siding/Trim - Repair

- Some minor warping and cupping, but in general, all material exhibits typical signs of wear and deterioration for a property of this age.
- This material typically lasts 30 - 50 years, depending on how well it is maintained throughout the years.
- In order to keep up the appearance of the community and to ensure a maximum life of siding, we have established a Reserve allowance for repairs and some replacement every staining cycle.

Allowance for repairs prior to staining

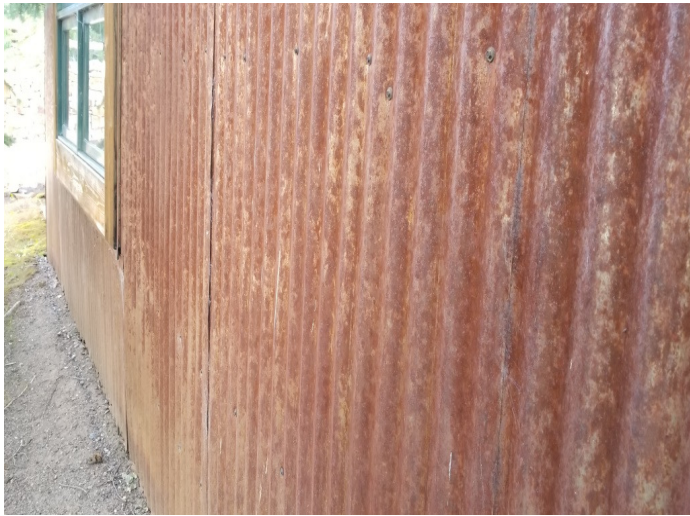
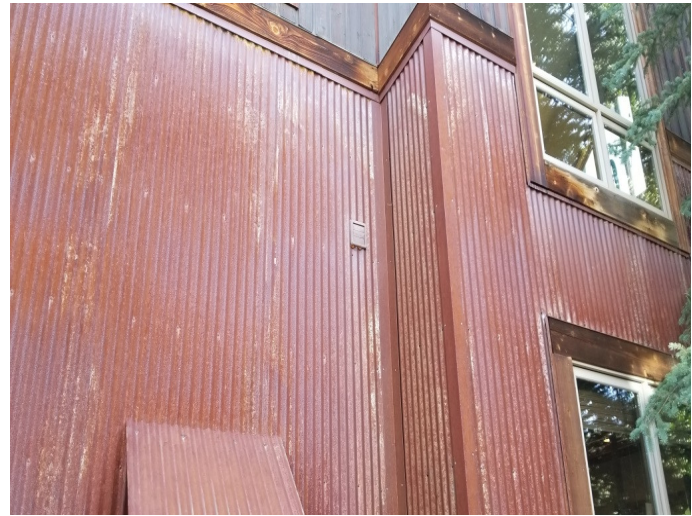
Comp #: 306 Corrugated Steel - Replace

- A few loose areas were noted around joints. Siding materials are constructed of a corrugated steel that has a rusted appearance, which is typical for this type of product.
- Product is very similar to the roof materials that were installed.
- According to a local contractor, this material has a life expectancy of 50+ years under normal conditions.
- Therefore, Reserve funding is not required at this time for this component due to extended life expectancy.
- Repair on an as needed basis with general operating funds.

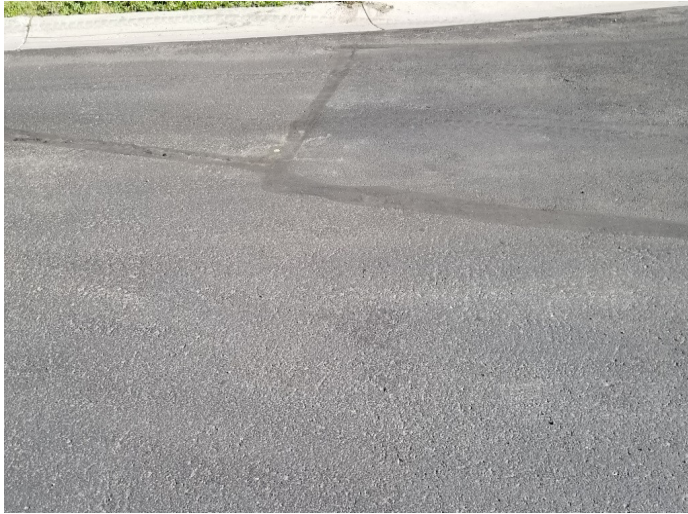
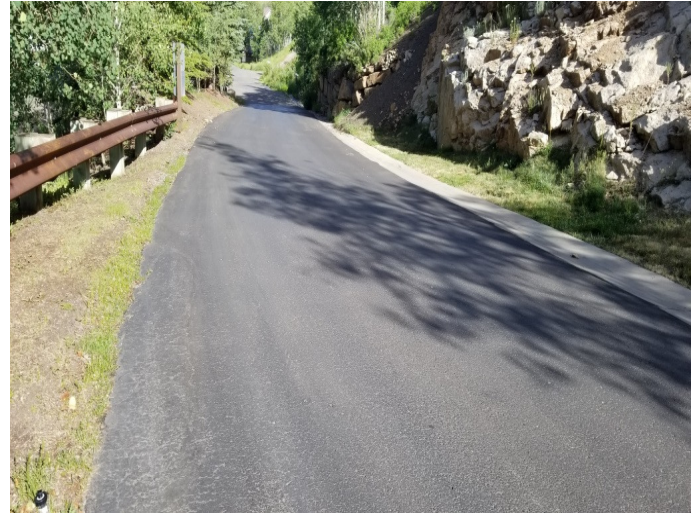
Comp #: 401 Asphalt - Overlay

- This line item is for major replacement of asphalt pavement or a roto mill and resurfacing, the decision regarding which applications and products to use is ultimately up to the BOD
- The costs of these projects vary depending on the product chosen, we have provided an average cost for substantial application of a new surface
- Research options and consult a reputable contractor prior to deciding on a product for street/parking resurfacing.

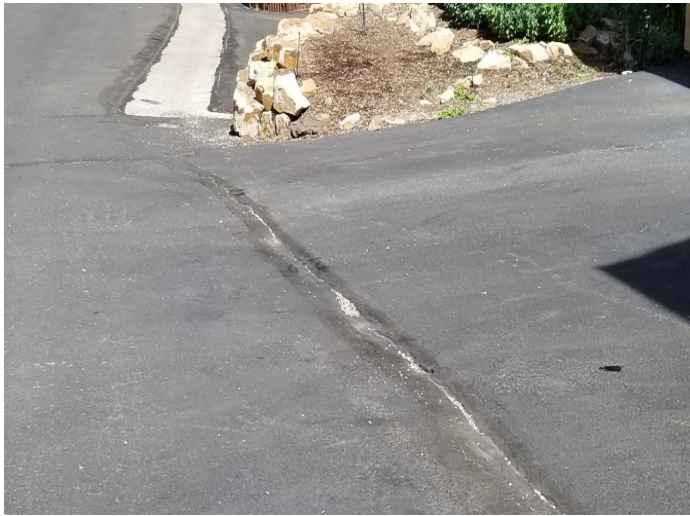
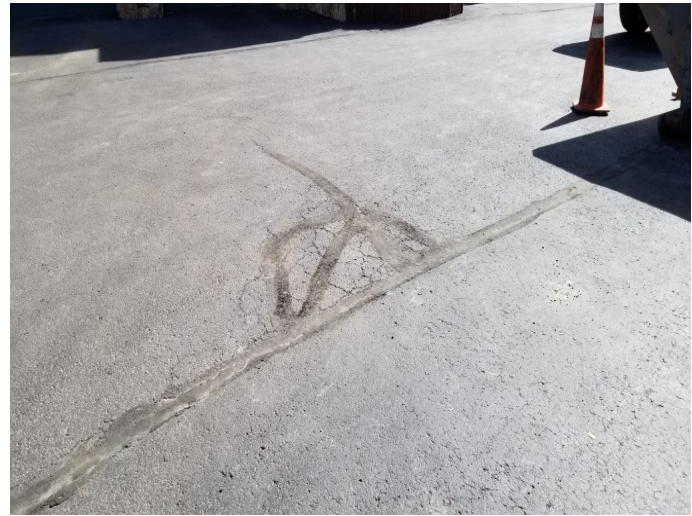
Comp #: 402 Asphalt - Seal Coat/crack fill

- Surface treatments are used to extend the useful life of asphalt and to help maintain aesthetics; there are a broad range of products to choose from so we recommend consulting a reputable contractor for your community's needs.
- The recommendation is an allowance for the mid range surface treatments that are available in today's market.
- Expect to seal coat, chip seal or slurry seal asphalt every 2 - 3 years, as the asphalt ages it may be necessary to adjust the frequency and or cost of these projects.
- Based on observed condition, we recommend sealing in 2021.

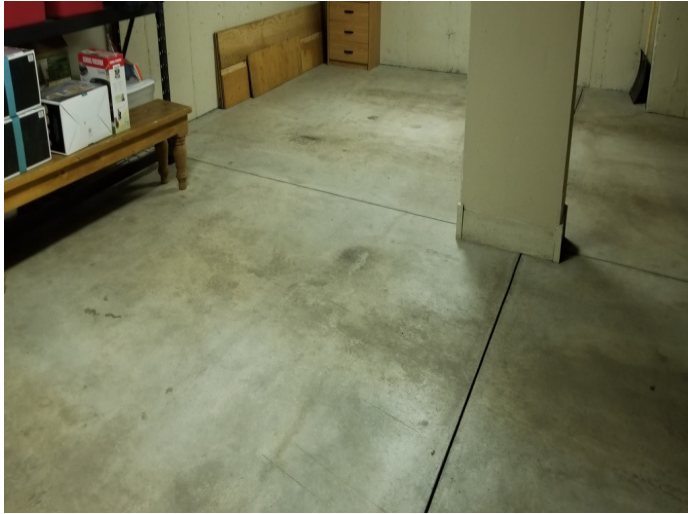
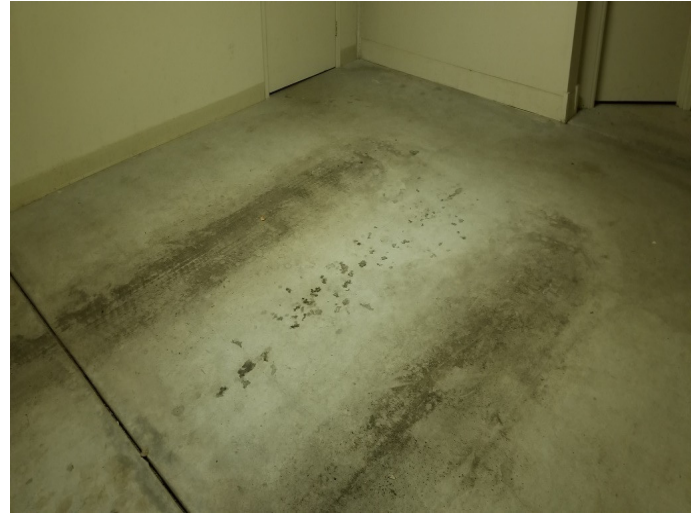
Comp #: 403 Concrete - Partial Replace

- No unusual conditions were noted at time of site visit.
- Concrete is protected from elements that will cause deterioration where repairs will become necessary.
- At this time, we do not see a need to Reserve for major repairs or replacement. Repair on an as needed basis with general operating funds.

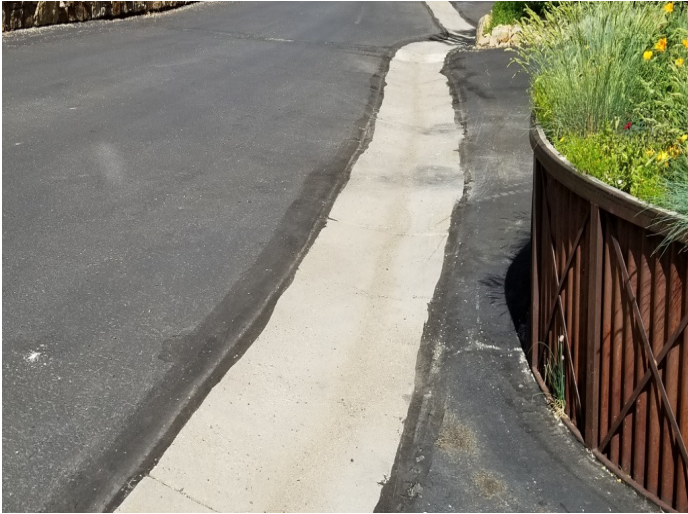
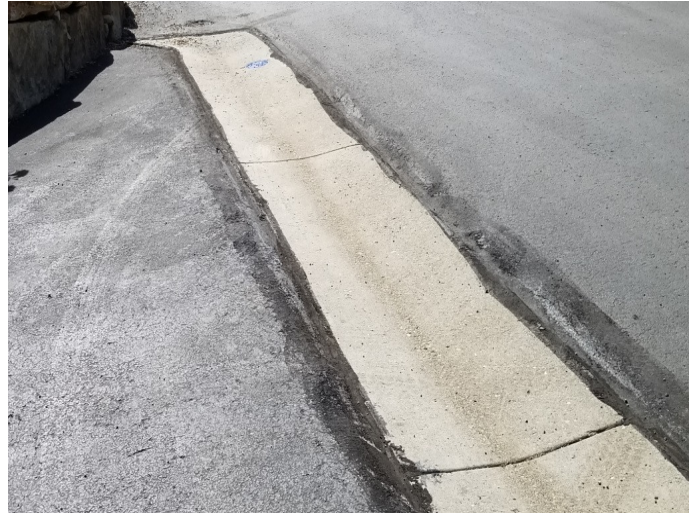
Comp #: 406 Concrete Drain Swales - Repair/Replace

- We recommend coordinating these repairs along with asphalt work for best cost estimate since asphalt companies can also perform concrete repairs.
- Since it is unlikely that all concrete surfaces will need to be repaired at the same time, we have established an allowance for periodic repairs to a percentage of the total area (20%, or 325 GSF) every 6 years.
- Therefore, we suggest establishing a Reserve fund to repair and replace approximately

Allowance to repair 20% of area every 6 years

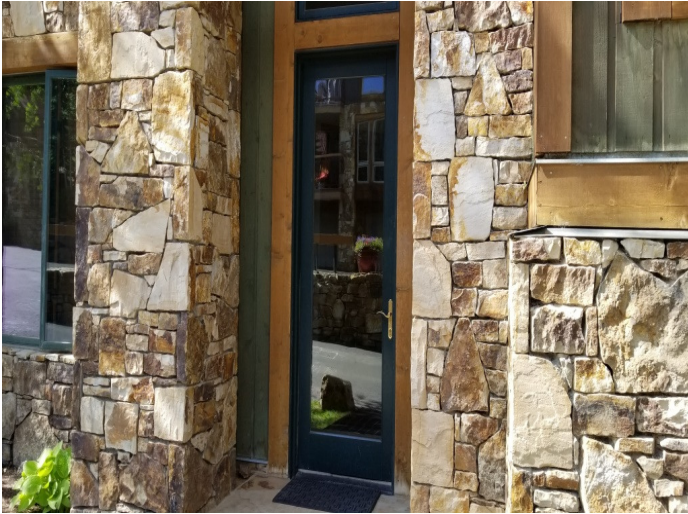
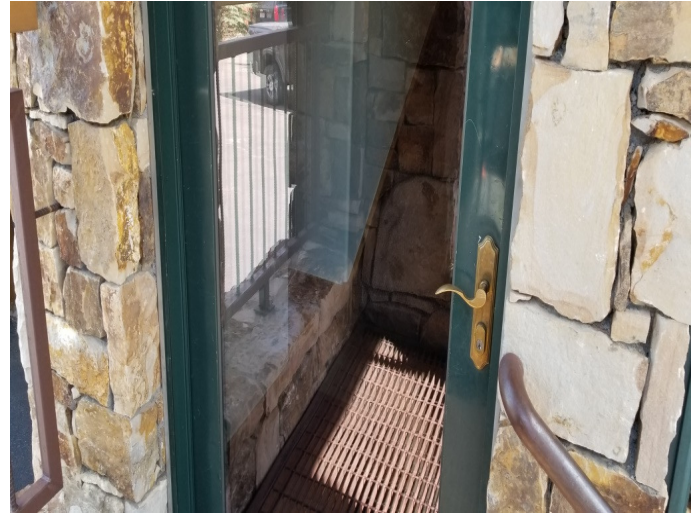
Comp #: 501 Common Doors - Replace

- Entry doors are exposed to elements, so it is possible replacement will be sooner than normal.
- Interior common doors are functioning, some were out of alignment where the door was sticking to the door frame.
- Due to varying levels of exposure to elements and different levels of use, we suggest Reserving for partial replacement of 4 doors every 5 years.

Allwoance to replace 4 doors every 5 years

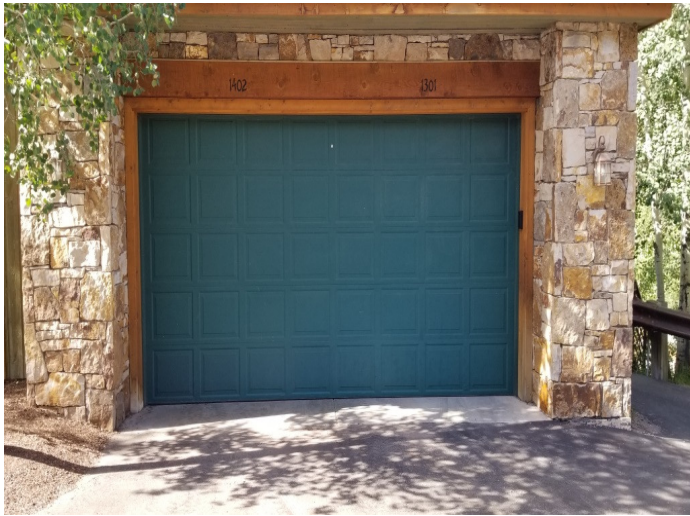
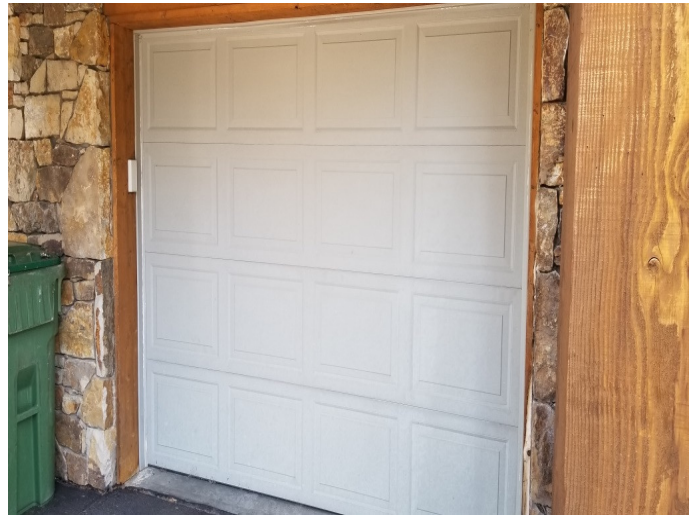
Comp #: 502 Garage Doors - Replace

- It appears one of the doors was recently replaced. Reason unknown.
- This type of door has a life expectancy of 20 - 25 years, depending on quality of door and level of use.
- Over a period of time, dings and dents will appear and eventually become aesthetically displeasing.
- Replacement will be eventually required to maintain the appearance of the property. We suggest replacing the doors at the same time for best replacement cost estimate.

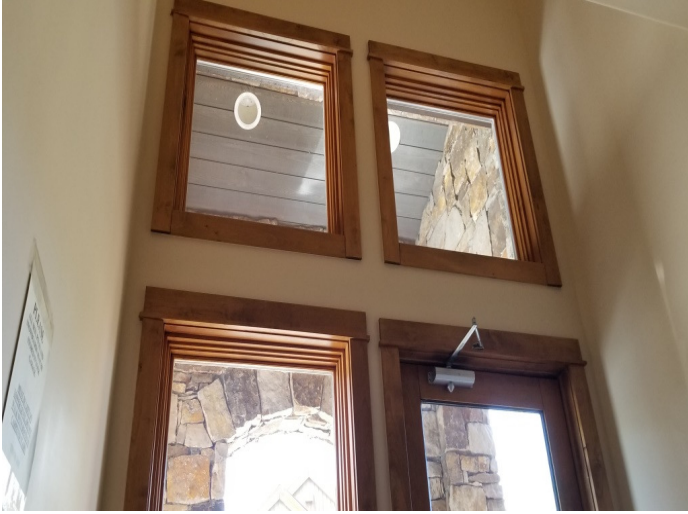
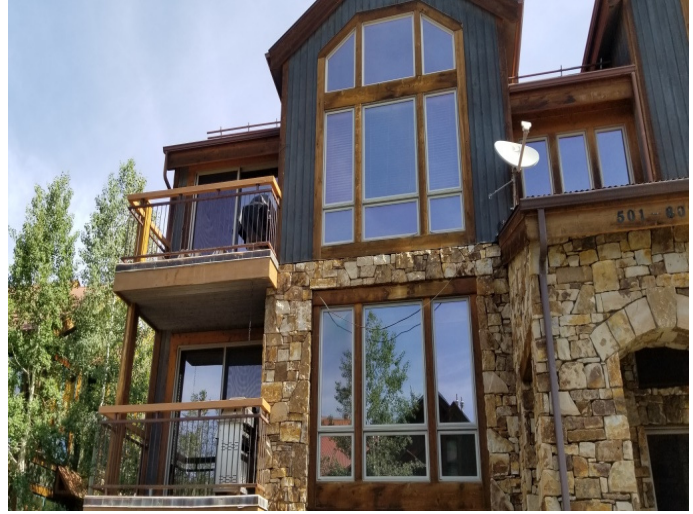
Comp #: 506 Common Windows - Replace

- No unusual conditions were observed or reported at time of inspection.
- There were no signs of condensation buildup or air leaks in the windows.
- These are double pane windows and have a life expectancy of 25 - 30 years under normal conditions.
- Funding is included for replacement of the windows in the common areas only.
- This budgeted line item does not include the windows in each individual unit. These are the responsibility of each individual owner.

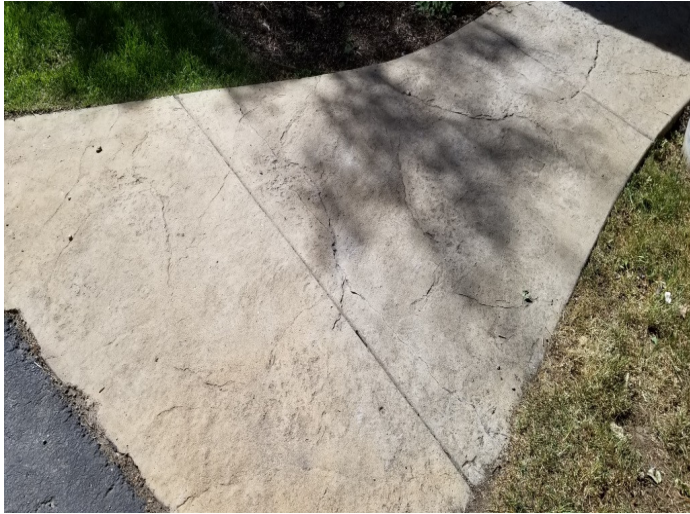
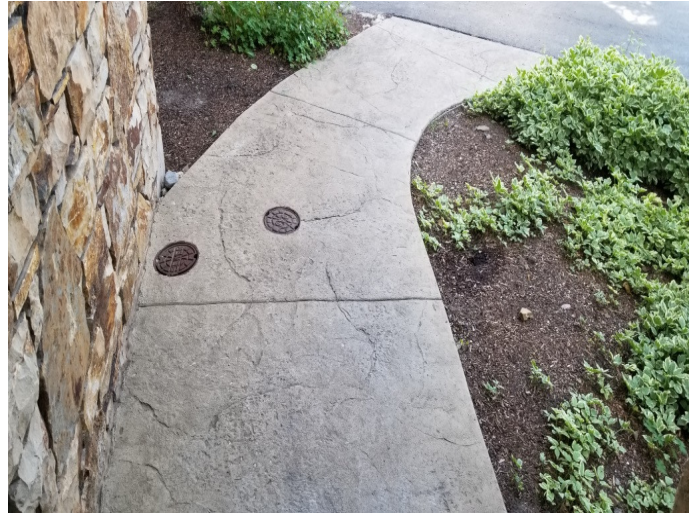
Comp #: 602 Stamped Concrete - Replace (Bldg 5)

- While periodic repairs are a possibility, with repairs, it is difficult to match the design of the stamp and the color.
- Therefore, we recommend replacement of the driveway every 20 - 25 years.

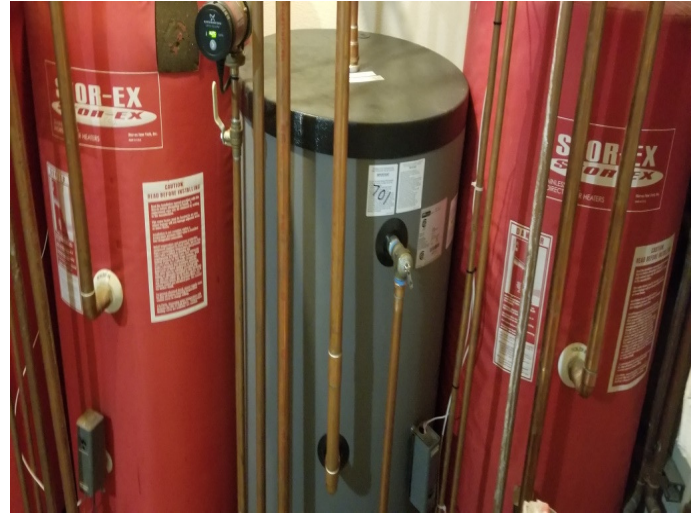
Comp #: 702 Mechanical Equipment - Replace

- It was reported the responsibility of all mechanical equipment has been turned over to the individual owner who's unit the equipment services.
- Therefore, all Reserve funding for mechanical equipment has been removed from this report.

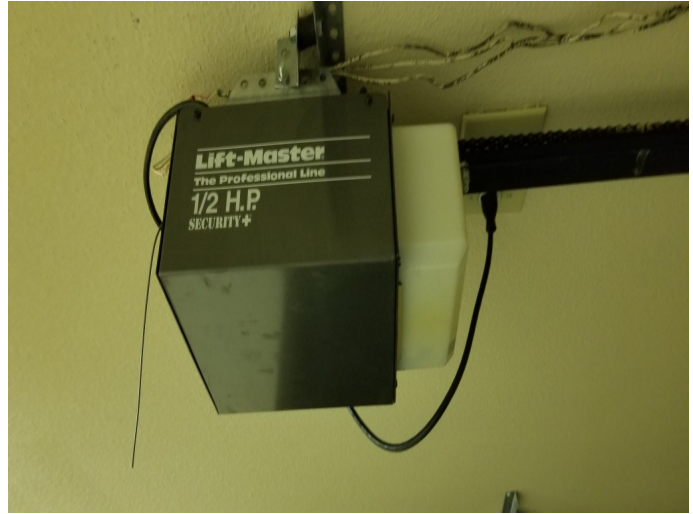
Comp #: 906 Garage Door Openers - Replace

- Due to different ages and conditions, we suggest establishing Reserve funds to replace 8 openers every 6 years

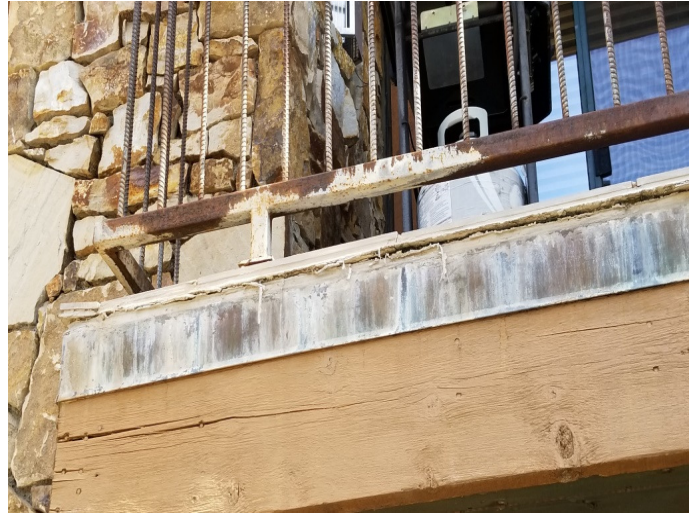
Comp #: 1002 Iron Railings - Replace

No significant evidence of deterioration or problems since our last inspection. There was minor rust noted at the connections and solder joints, but that is expected for this type of railing material. Due to an indefinite life expectancy for railings, there is no separate Reserve funding required for this component.

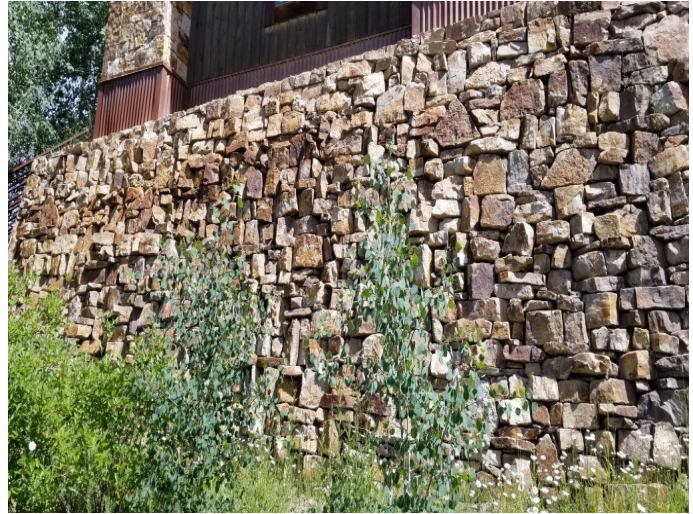
Comp #: 1011 Rock Retaining Wall - Replace

- No observed movement or deterioration of walls.
- At this time, reserve funding is not required due to observed conditions and no physical evidence of deterioration or movement.

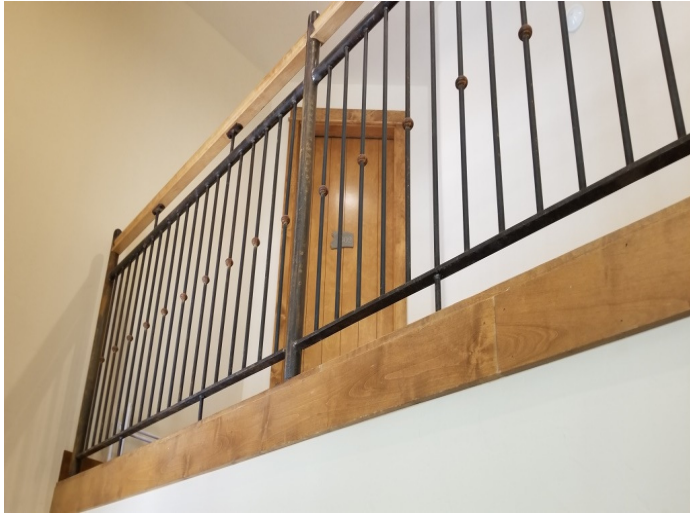
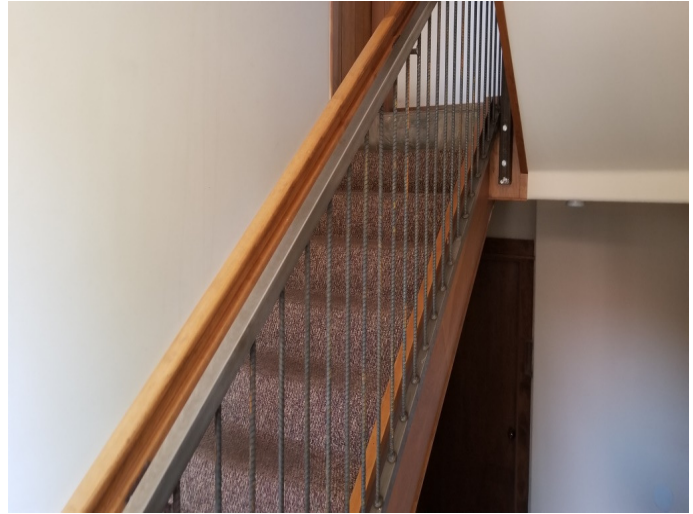
Comp #: 1401 Interior Handrails - Replace

No evidence of deterioration or problems at time of inspection. Due to an indefinite life expectancy for railings due to limited exposure to elements, there is no separate Reserve funding required for this component. The wood caps should be varnished as part of interior painting cost.

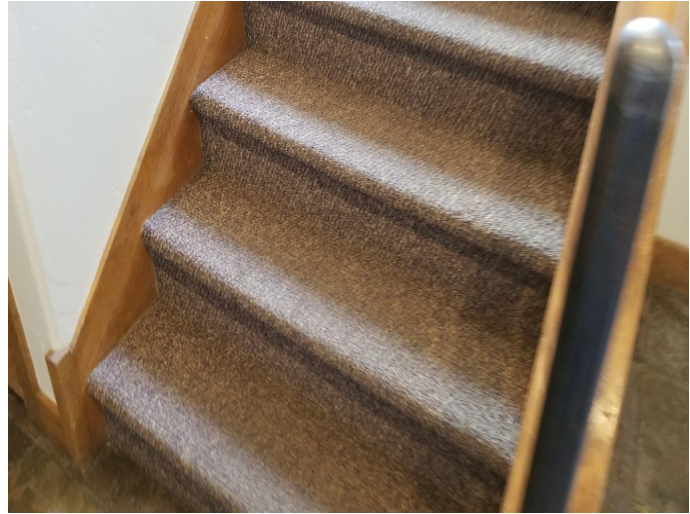
Comp #: 1501 Carpeting - Replace

- Appears to have been replaced within the past several years, but information as to when it was done was not available.
- We suggest replacing all interior carpeting at the same time to get the best cost estimate.
- Remaining life is based on average age and condition of carpeting.

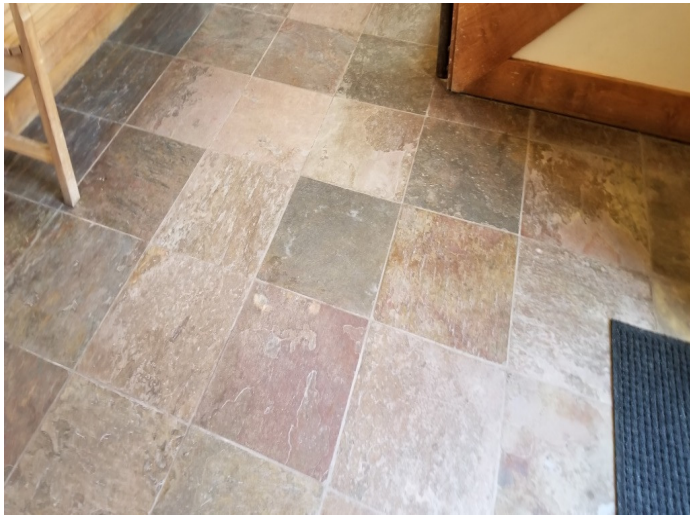
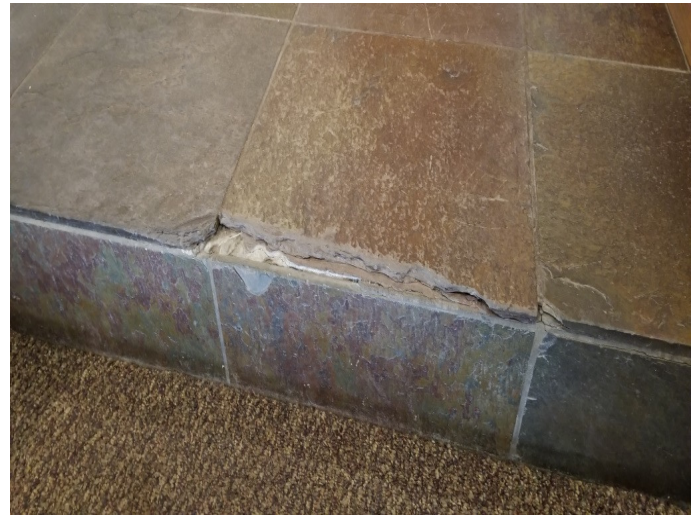
Comp #: 1504 Slate Tile - Replace

- A couple chipped and cracked pieces were observed at time of site visit
- Some associations and clients believe this tile is now a dated material and most are replacing with modern appearance.
- Based on age of building and observed conditions of a few problem areas, we recommend replacing at the same time as the next carpet cycle (in 3 years)

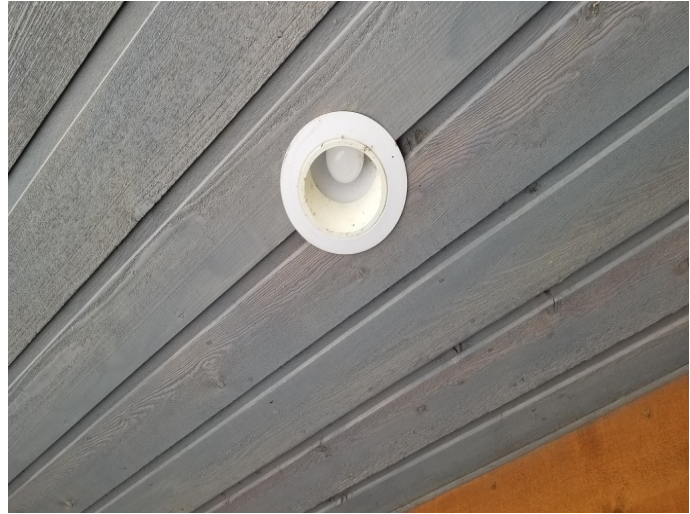
Comp #: 1602 Exterior Wall Mount - Replace

- While replacement can occur on an as needed basis, it is our opinion and recommendation to replace all lights at the same time every 20 - 25 years to maintain a consistent appearance throughout the property.
- By replacing multiple fixtures, the association will be able to obtain a quantity discount for replacement and installation of the fixtures.
- Due to a low replacement cost, can lights can be replaced as needed with general operating funds.

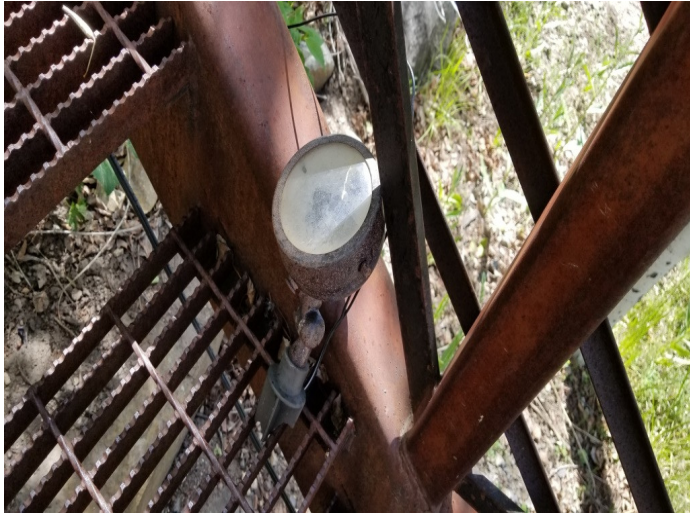
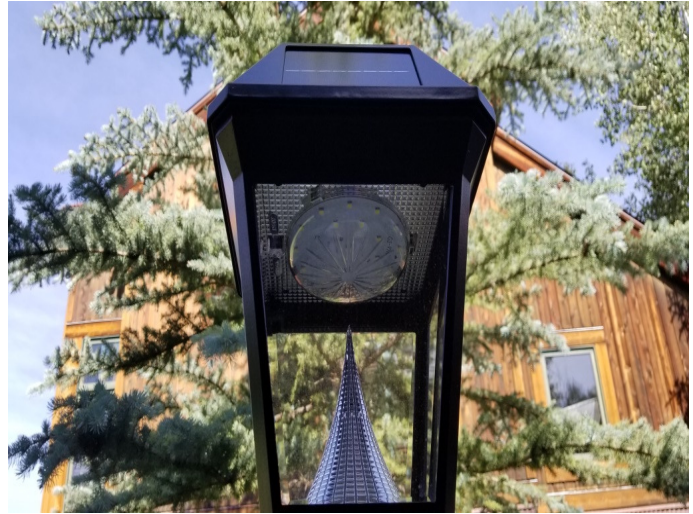
Comp #: 1604 Low Voltage Lights - Replace

- These lights are inexpensive to replace and any maintenance or expense associated with these lights should be handled with general operating funds.

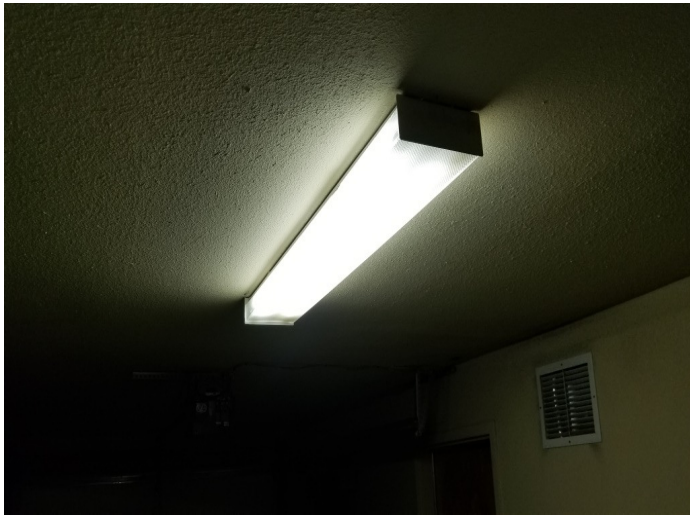
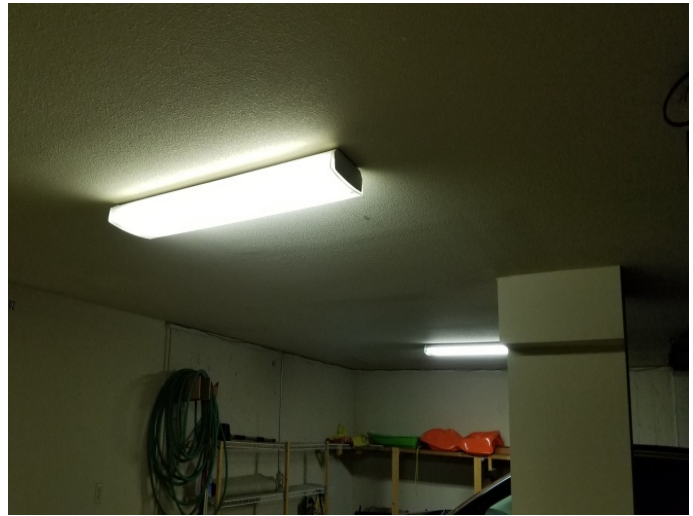
Comp #: 1607 Florescent Tube Lights - Replace

- No unusual conditions observed during inspection.
- Individual replacement cost for this type of fixture is too small for Reserve designation.
- Replace as needed with general operating funds.

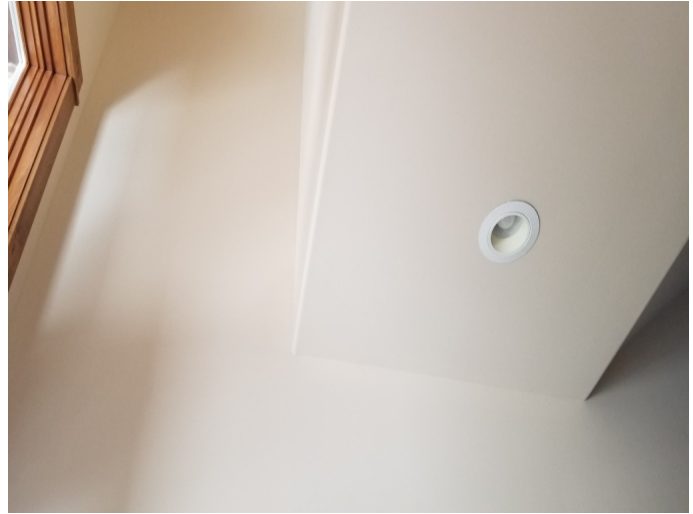
Comp #: 1608 Interior Can Lights - Replace

- The individual replacement cost (less than \$100 each) is too small for separate Reserve designation.
- Replacement can occur as needed without disrupting the overall aesthetics of the community.
- Therefore, we suggest replacing these on an as needed basis with general operating funds.

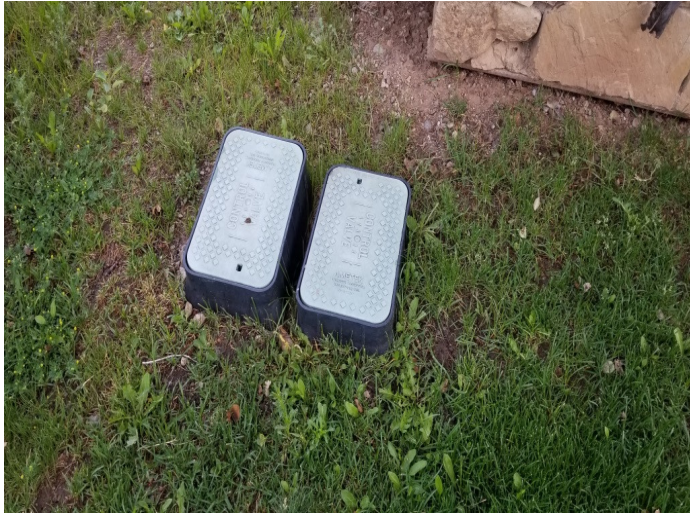
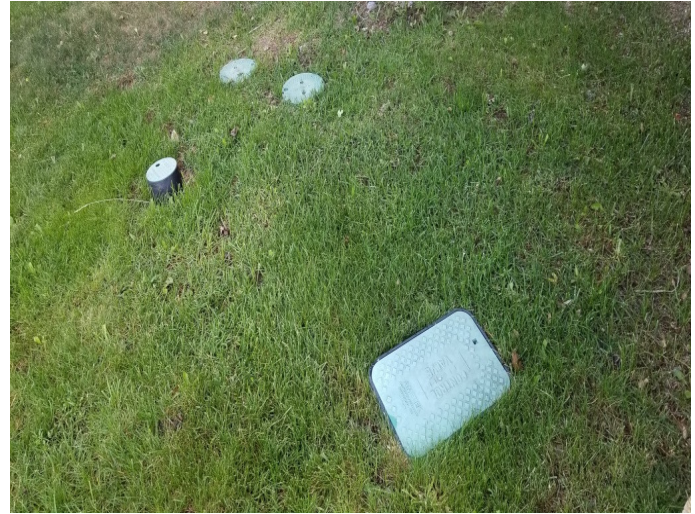
Comp #: 1701 Irrigation System - Repair

- System is in great condition according to the landscaper and there are no current needs for major repairs, or expectations of future replacement at this time.
- At this time, there is no expectancy to completely replace the system and Reserve funding is not recommended.

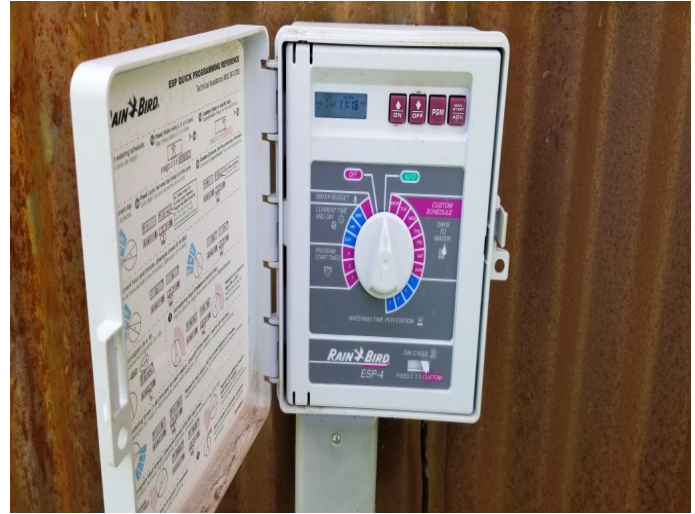
Comp #: 1703 Irrigation Controllers - Replace

- Expect to replace irrigation controllers every 15 - 18 years if properly maintained and under normal conditions.
- Funding is for replacement with a similar controller.
- Evapotranspiration (also known as ET) based controllers are also available, but cost significantly more. ET timers are more efficient and can be controlled remotely by landscaping experts, saving the association irrigation water costs.

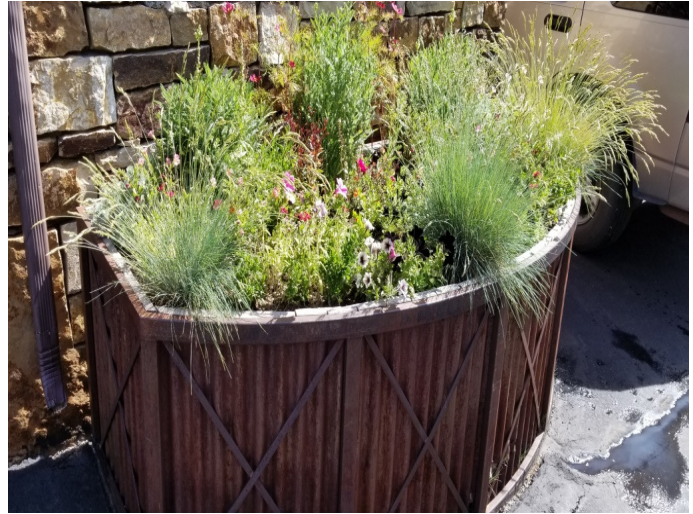
Comp #: 1809 Planter Boxes - Refurbish

Each box is 2 1/2 feet in height with a rubber membrane as a liner to prevent water from leaking through materials. Some of these rubber liners are beginning to tear in a few areas. The exterior is corrugated copper and should have an extended life expectancy. The plant material is similar to other landscaping which should be treated as an annual operating expense. Minor repairs can be performed on the planters as a general maintenance expense. Therefore, no separate Reserve funding is required for this component.

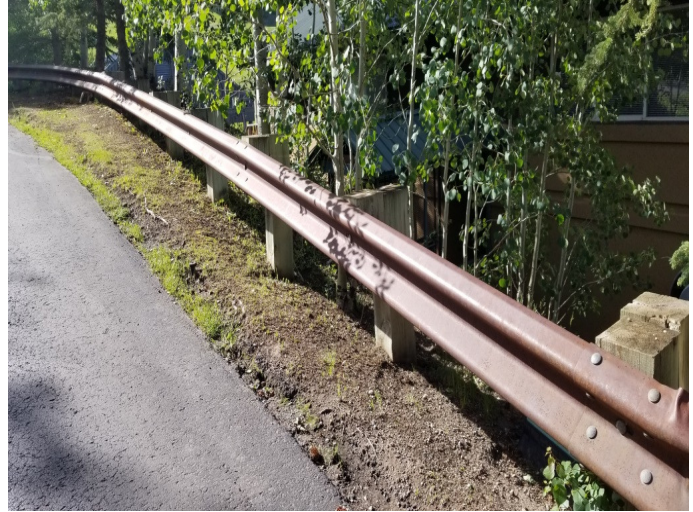
Comp #: 2001 Guardrail - Replace

Guardrail and support posts are structurally stable and in good condition with no damage noted at time of inspection. Replacement timeframe will depend on if the guardrail is hit by a vehicle. Under normal conditions, and no accidents, the guardrail should have an indefinite life expectancy and replacement is unlikely. Therefore, no separate Reserve funding is required for this component. If the guardrail is damaged during an accident, plan on insurance covering the repair expense to the necessary sections.

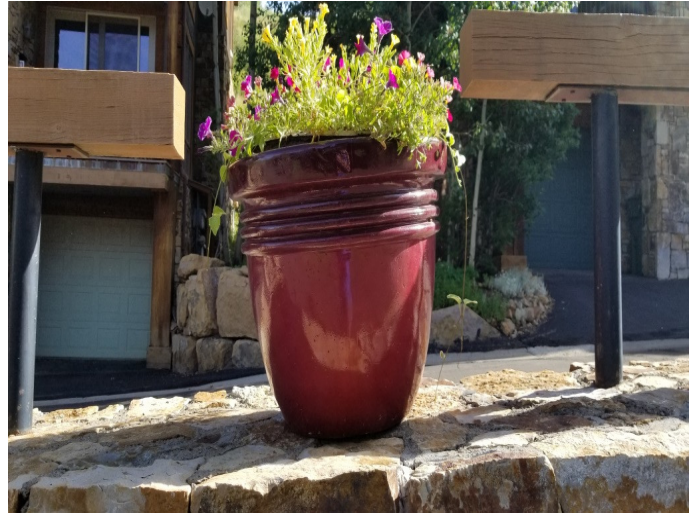
Comp #: 2002 Flower Pots - Replace

- New flower pots were purchased within the past several years.
- Due to unpredictable life expectancy and possible low replacement cost, we recommend performing this expense on an as needed basis with general operating funds.

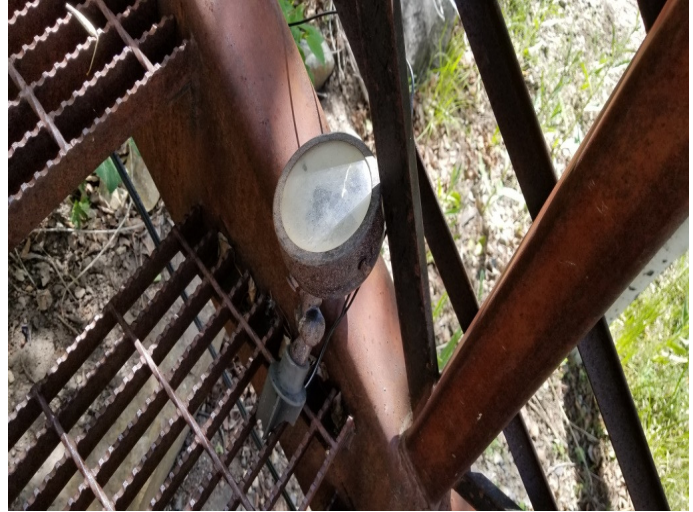
Comp #: 2020 Metal Stairways - Replace

No unusual conditions or signs of deterioration was noted at time of inspection. These stairway systems have an indefinite life expectancy and future replacement is unlikely. Therefore, no Reserve funding is required for this component.
