Thursday, September 19, 2019

Level 2, Premium Reserve Analysis

Terraces at Meadow Run

101-1402 Meadow Run

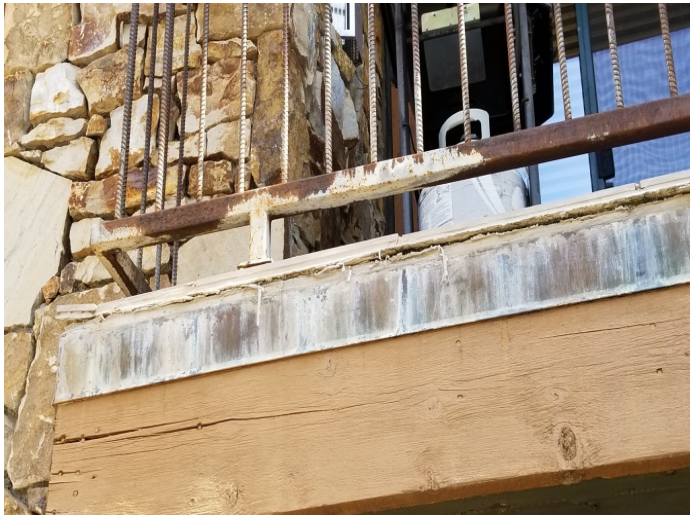
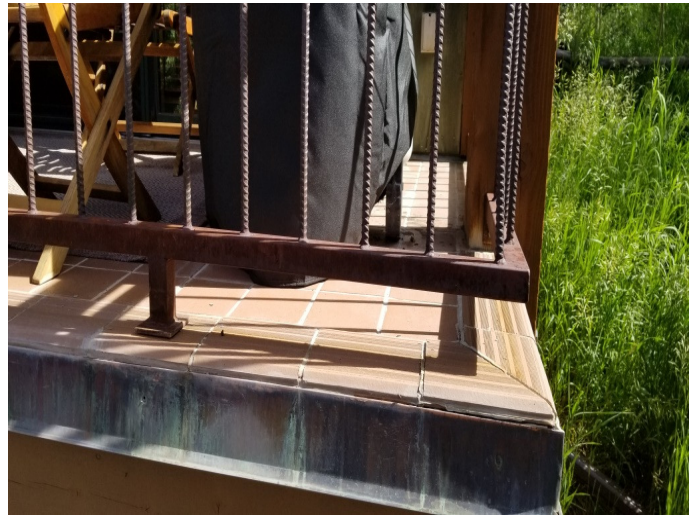
Comp #: 603 Balcony Decks - Replace (1 & 2)

Location: **Balcony decks of building 1 and 2**

\$40/GSF; Estimate to replace

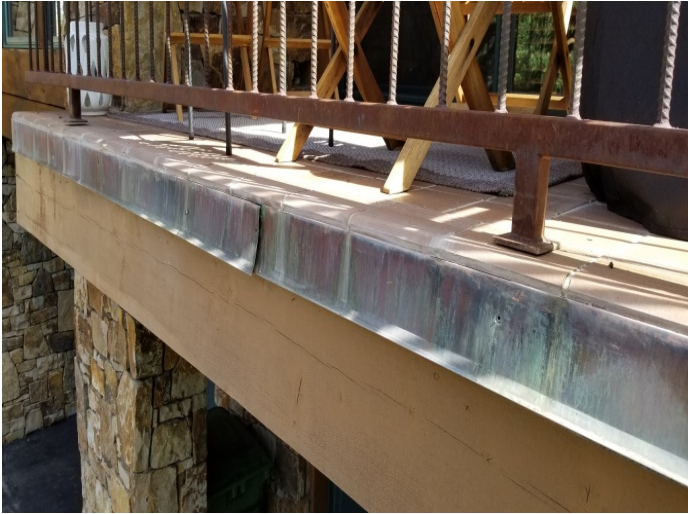
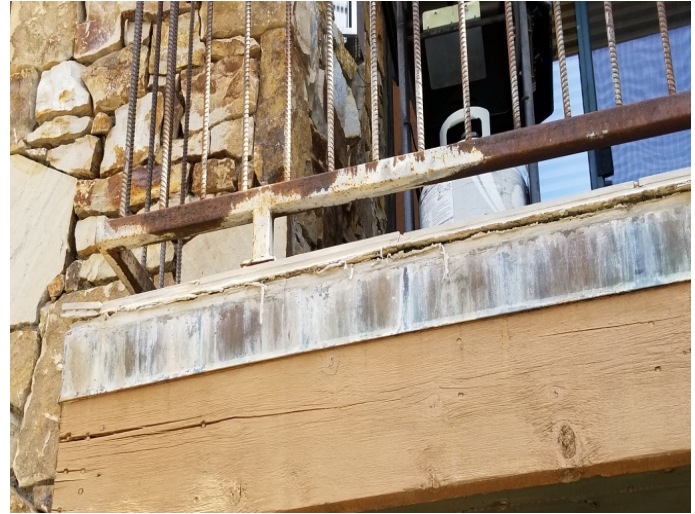
Comp #: 603 Balcony Decks - Replace (3 & 4)

Location: **Balcony decks of building 3 and 4**

Best Cost: **\$24,000**
\$40/GSF; Estimate to replace

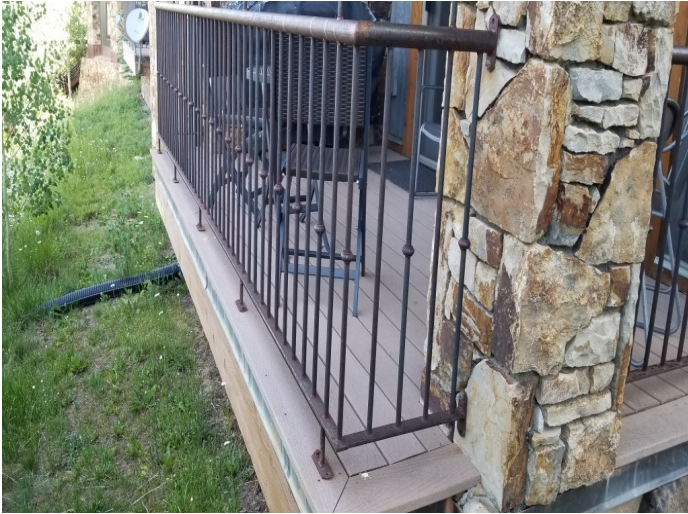
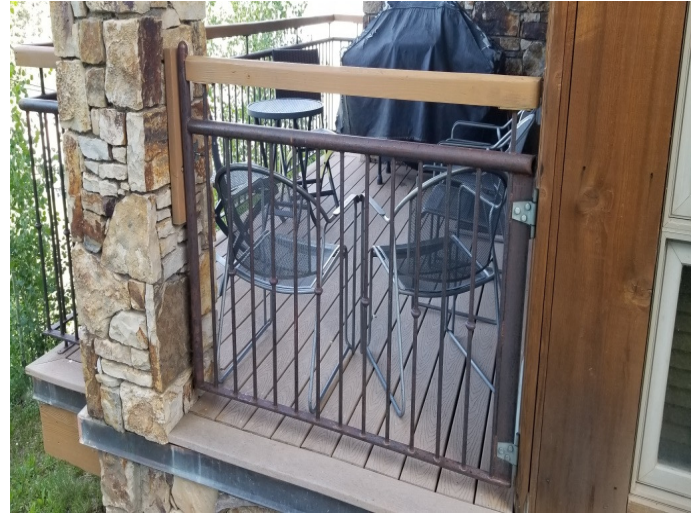
Comp #: 609 Composite Decks - Replace (5, 6, 7)

Location: **Rear decks of building 5, 6, and 7**

Best Cost: **\$48,000**
\$40/GSF; Estimate to replace

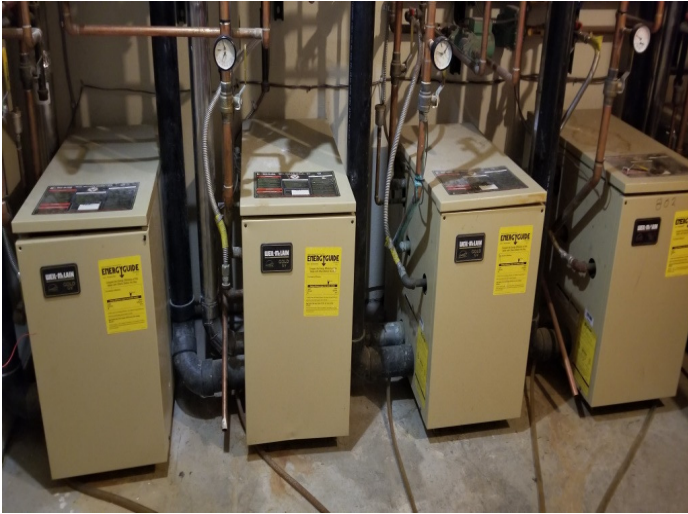
Comp #: 702 Mechanical Equipment - Replace

- It was reported the responsibility of all mechanical equipment has been turned over to the individual owner who's unit the equipment services.
- Therefore, all Reserve funding for mechanical equipment has been removed from this report.

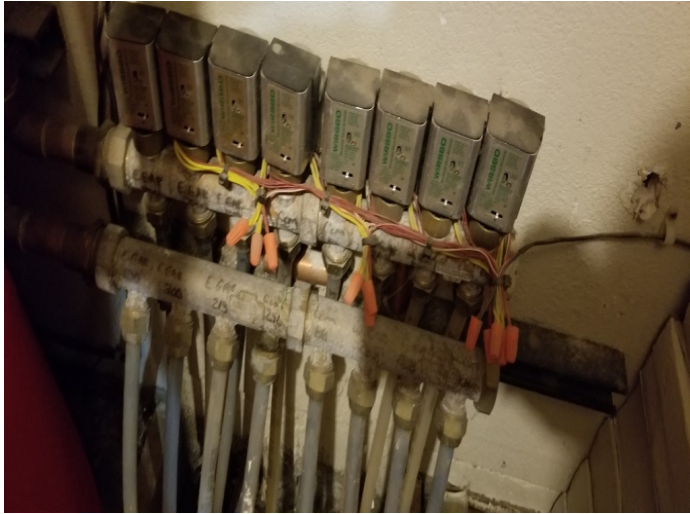
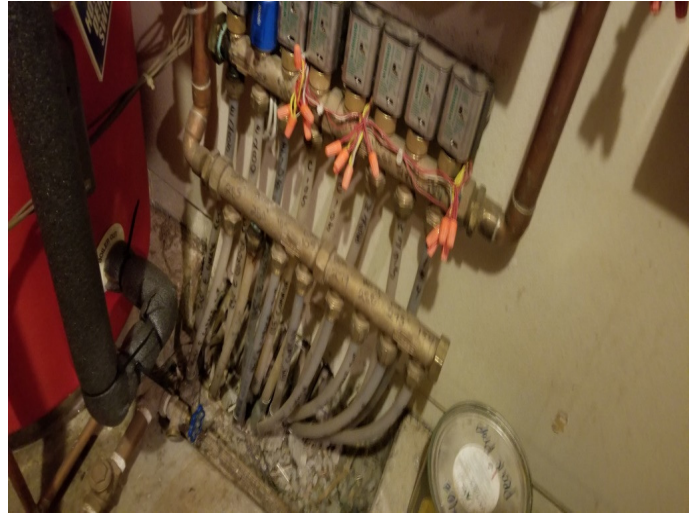
Comp #: 707 Snow Melt System - Replace

Location: **Buildings 1-4**

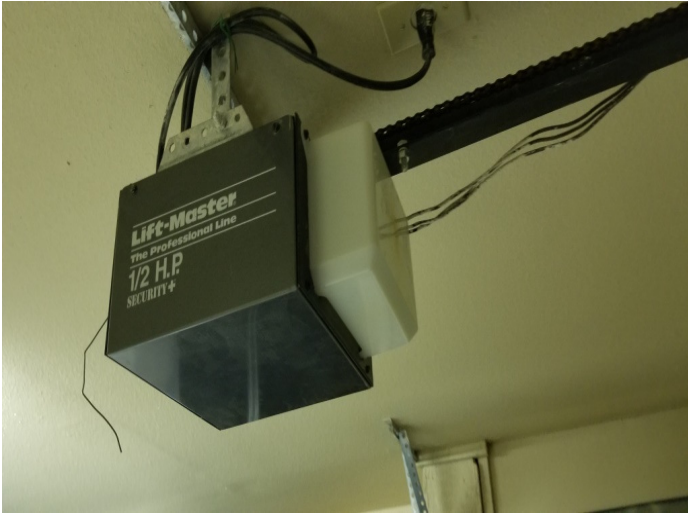
Comp #: 906 Garage Door Openers - Replace

- Due to different ages and conditions, we suggest establishing Reserve funds to replace 8 openers every 6 years

\$875/opener; Estimate to replace and install

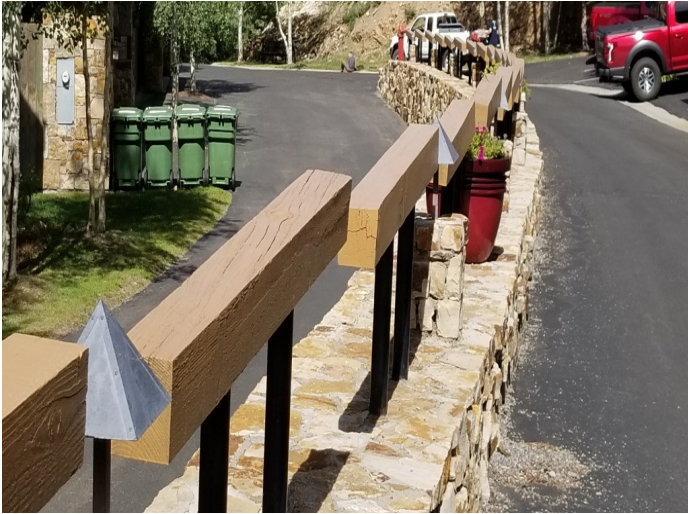
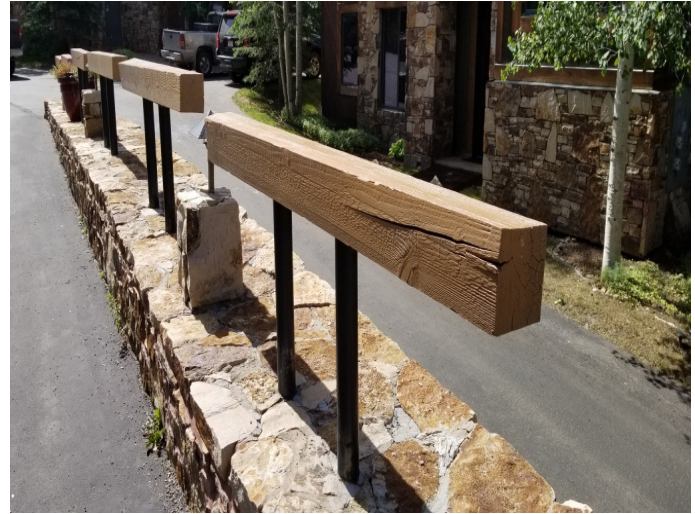
Comp #: 1001 Wood Rails on Wall - Replace

Location: **Center of property**

\$350/piece; Estimate to replace

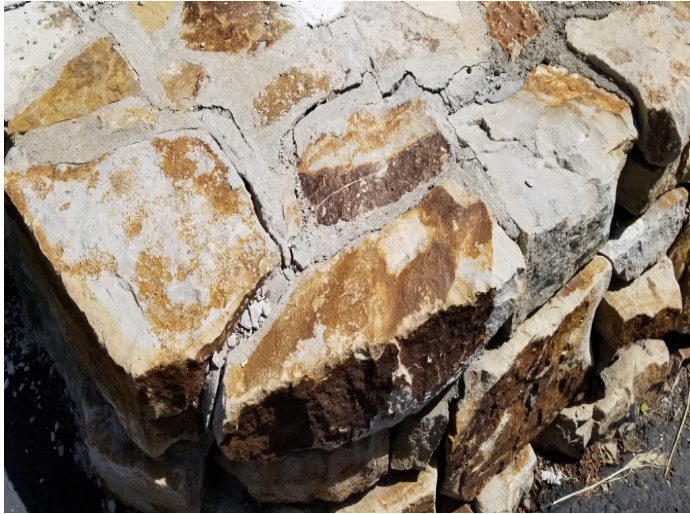
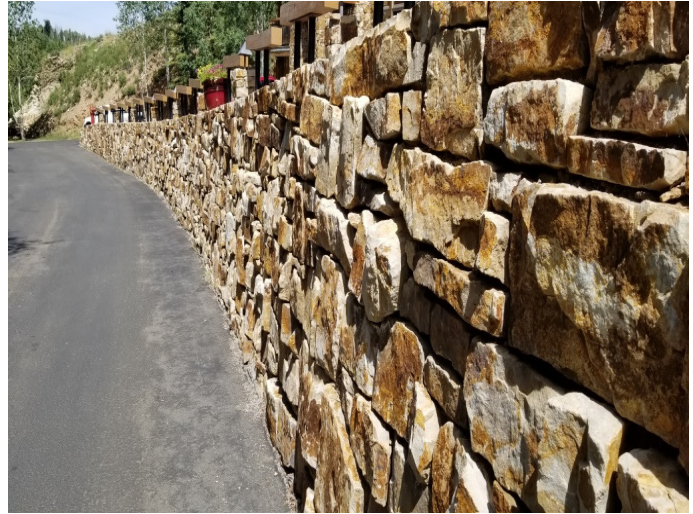
Comp #: 1005 Flagstone Wall - Replace

Location: **Down center of property**

Allowance for periodic repairs

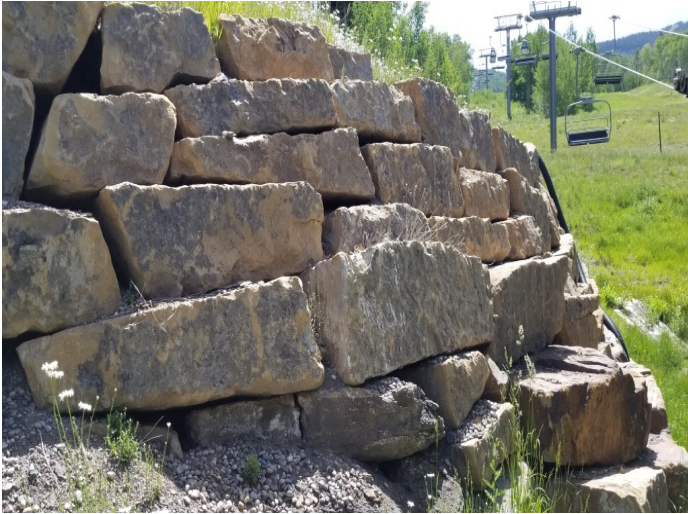
Comp #: 1011 Rock Retaining Wall - Replace

- No observed movement or deterioration of walls.
- At this time, reserve funding is not required due to observed conditions and no physical evidence of deterioration or movement.

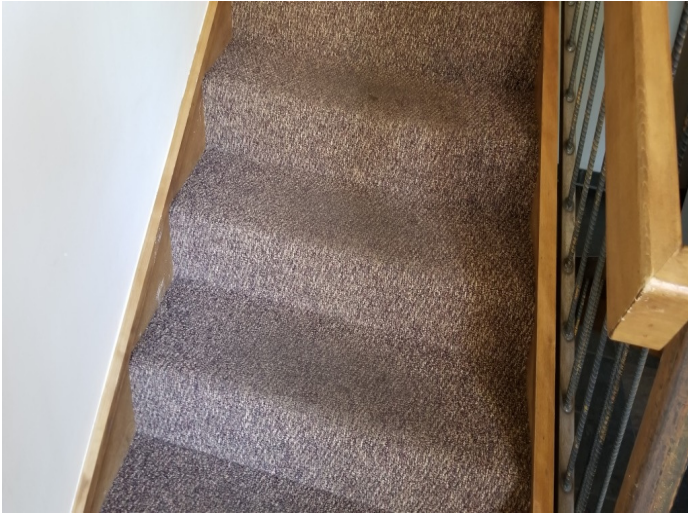
Comp #: 1501 Carpeting - Replace

- Appears to have been replaced within the past several years, but information as to when it was done was not available.
- We suggest replacing all interior carpeting at the same time to get the best cost estimate.
- Remaining life is based on average age and condition of carpeting.

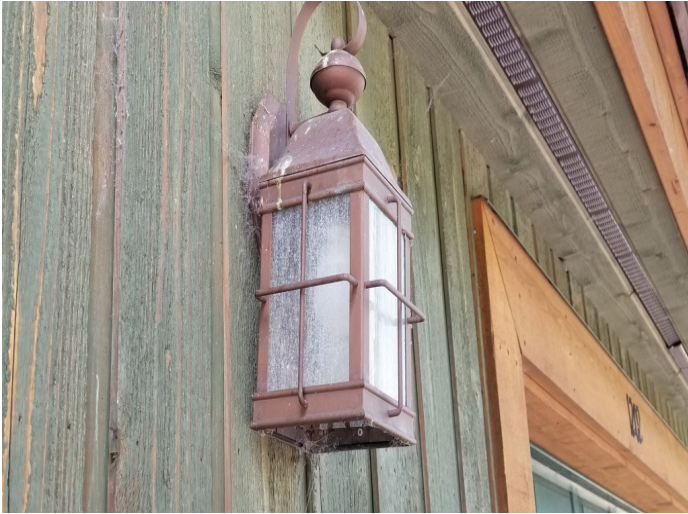
Comp #: 1602 Exterior Wall Mount - Replace

- While replacement can occur on an as needed basis, it is our opinion and recommendation to replace all lights at the same time every 20 - 25 years to maintain a consistent appearance throughout the property.
- By replacing multiple fixtures, the association will be able to obtain a quantity discount for replacement and installation of the fixtures.
- Due to a low replacement cost, can lights can be replaced as needed with general operating funds.

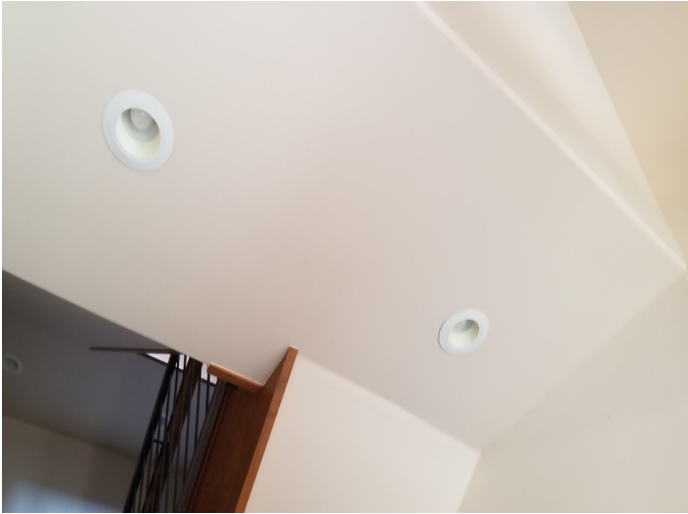
Comp #: 1608 Interior Can Lights - Replace

- The individual replacement cost (less than \$100 each) is too small for separate Reserve designation.
- Replacement can occur as needed without disrupting the overall aesthetics of the community.
- Therefore, we suggest replacing these on an as needed basis with general operating funds.

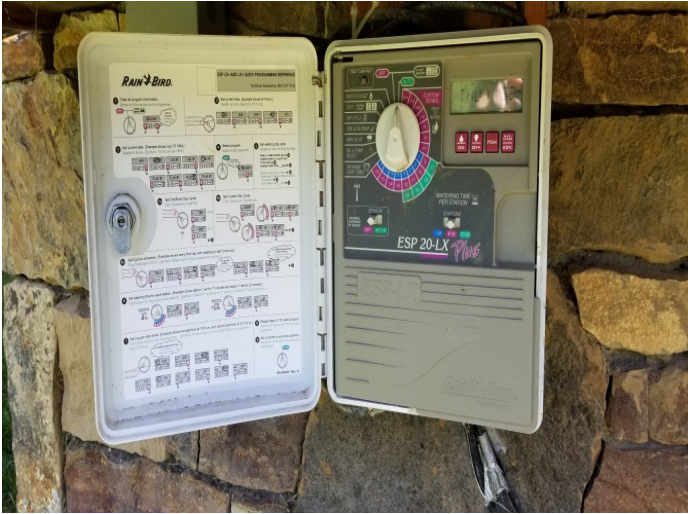
Comp #: 1703 Irrigation Controllers - Replace

- Expect to replace irrigation controllers every 15 - 18 years if properly maintained and under normal conditions.
- Funding is for replacement with a similar controller.
- Evapotranspiration (also known as ET) based controllers are also available, but cost significantly more. ET timers are more efficient and can be controlled remotely by landscaping experts, saving the association irrigation water costs.

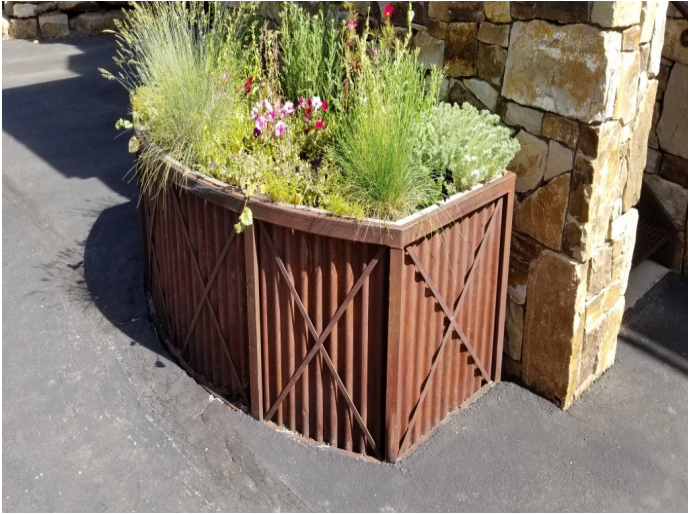
Comp #: 1809 Planter Boxes - Refurbish

Each box is 2 1/2 feet in height with a rubber membrane as a liner to prevent water from leaking through materials. Some of these rubber liners are beginning to tear in a few areas. The exterior is corrugated copper and should have an extended life expectancy. The plant material is similar to other landscaping which should be treated as an annual operating expense. Minor repairs can be performed on the planters as a general maintenance expense. Therefore, no separate Reserve funding is required for this component.

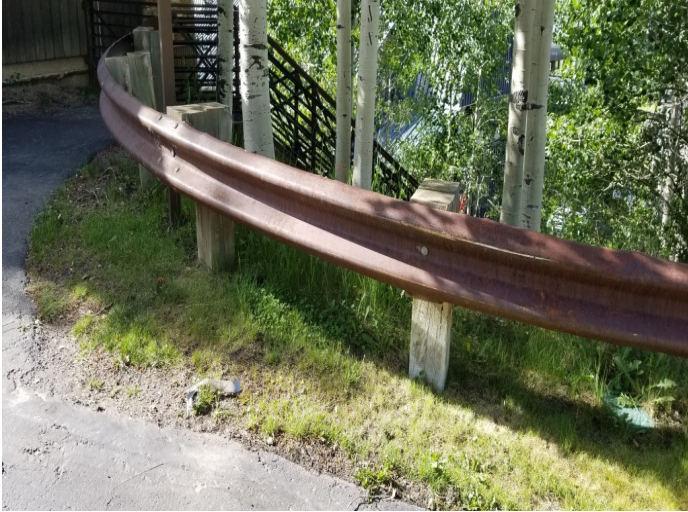
Comp #: 2001 Guardrail - Replace

Guardrail and support posts are structurally stable and in good condition with no damage noted at time of inspection. Replacement timeframe will depend on if the guardrail is hit by a vehicle. Under normal conditions, and no accidents, the guardrail should have an indefinite life expectancy and replacement is unlikely. Therefore, no separate Reserve funding is required for this component. If the guardrail is damaged during an accident, plan on insurance covering the repair expense to the necessary sections.

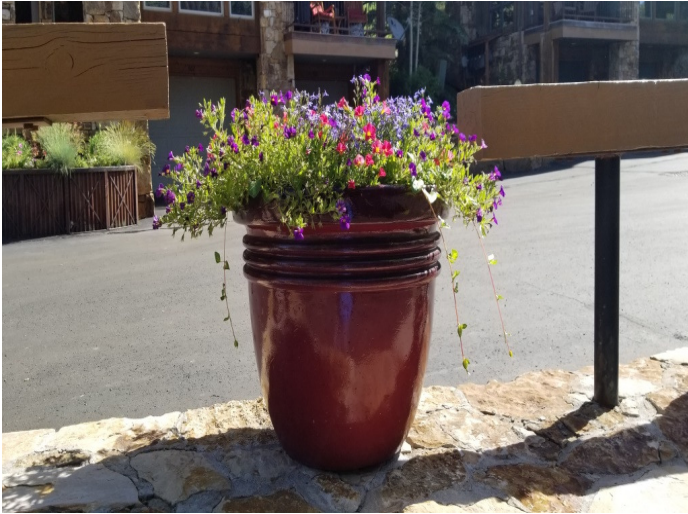
Comp #: 2002 Flower Pots - Replace

- New flower pots were purchased within the past several years.
- Due to unpredictable life expectancy and possible low replacement cost, we recommend performing this expense on an as needed basis with general operating funds.

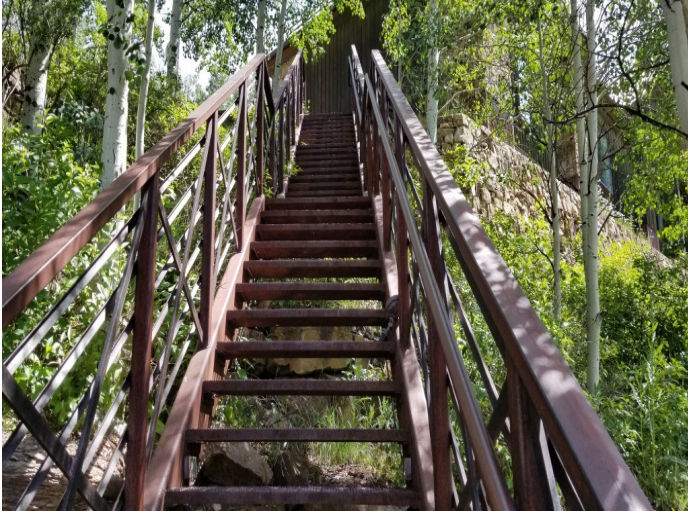
Comp #: 2020 Metal Stairways - Replace

No unusual conditions or signs of deterioration was noted at time of inspection. These stairway systems have an indefinite life expectancy and future replacement is unlikely. Therefore, no Reserve funding is required for this component.
